HISTORIC STRUCTURE REPORT

Architectural Data Section

LINDENWALD

MARTIN VAN BUREN NATIONAL HISTORIC SITE

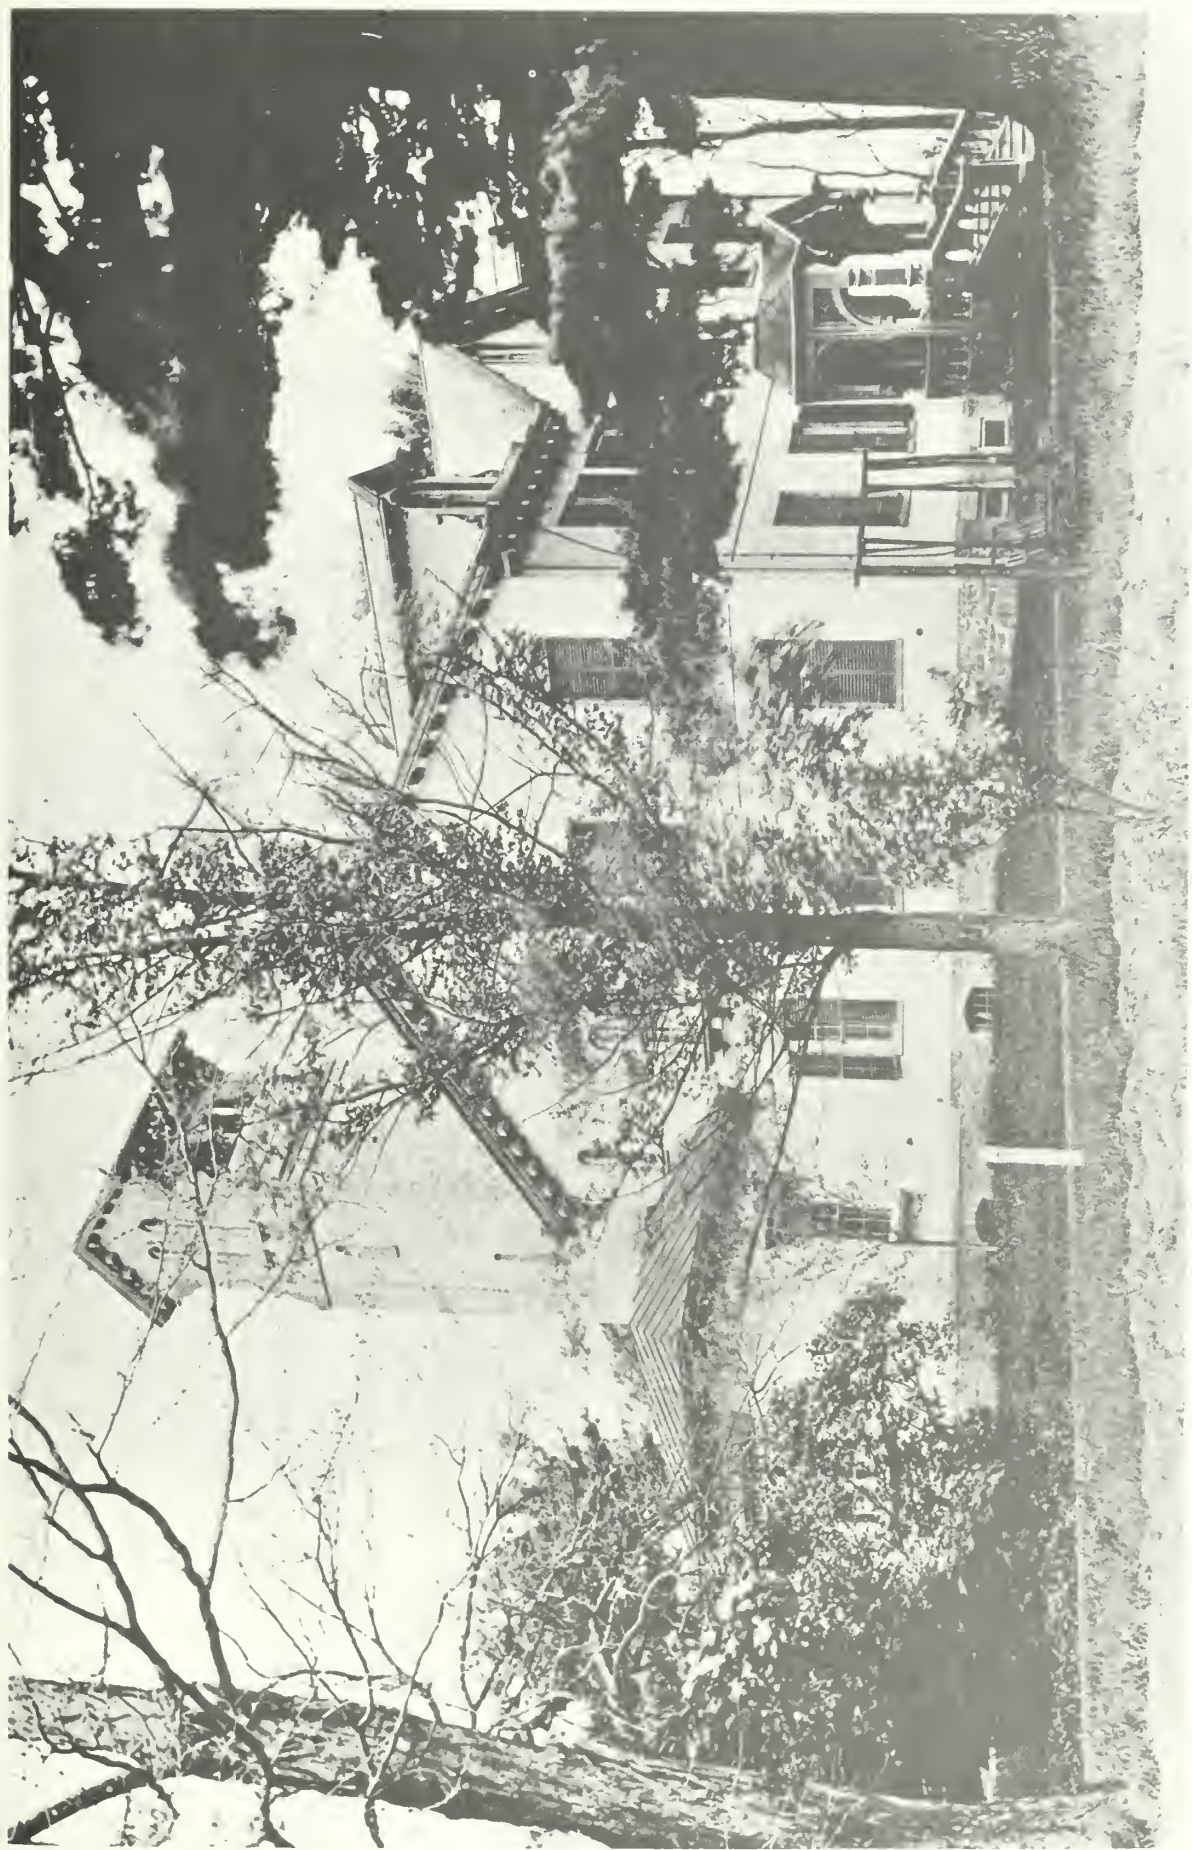
HP7. The Wagoners in Front of Lindenwald. This photograph probably predates 1917 because the subjects are Mr. and Mrs. Wagoner. Note the detail of the cast-iron bench and the expanse of lawn.

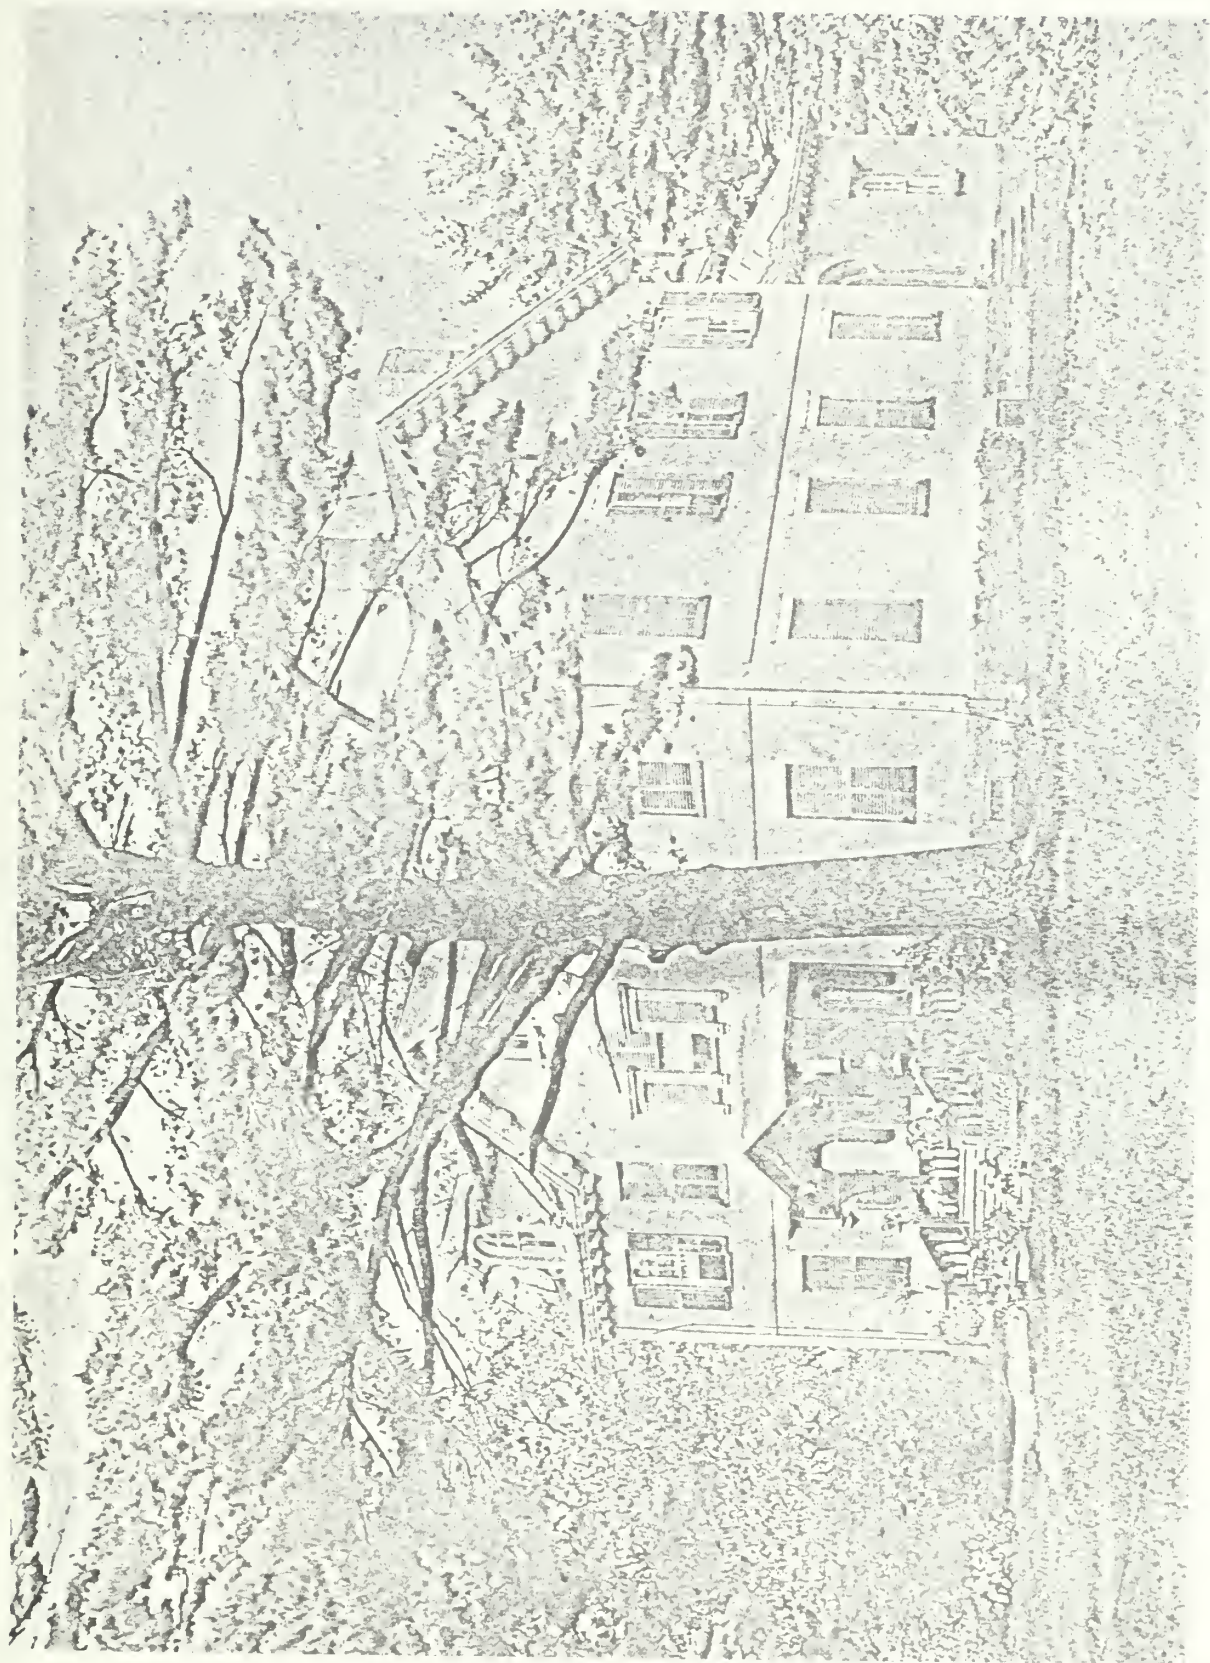
HP10. Lindenwald, East Elevation, ca. 1913. This photograph is from the New York State Archives, glass plate number 82, negative number 10643. The glass plate is dated 1913. The print presented here is an enlargement of the central part of the glass plate. Landscape features visible on the glass plate, but not included in this print, are the farm office, partially visible at the extreme left (south) side, an adjacent fence, the hitching post, the glider, a cauldron (cast iron?) at the base of the south pine tree, another cast-iron bench near the south pine tree, an outbuilding northwest of the house, and an extensive lawn with trees and shrubs. Within the area of this print, the following details should be noted:

Lightning rods and conductors are present.

The foundation, window frames, shutters, and front porch seem to be painted a dark tone. Sash, bricks, and cornice appear to be painted a lighter tone.

The south dormer sill box is askew. The north end of the north dormer sill box is detached.

Sheet-metal gutters have been added to the level eaves of the south dormer.

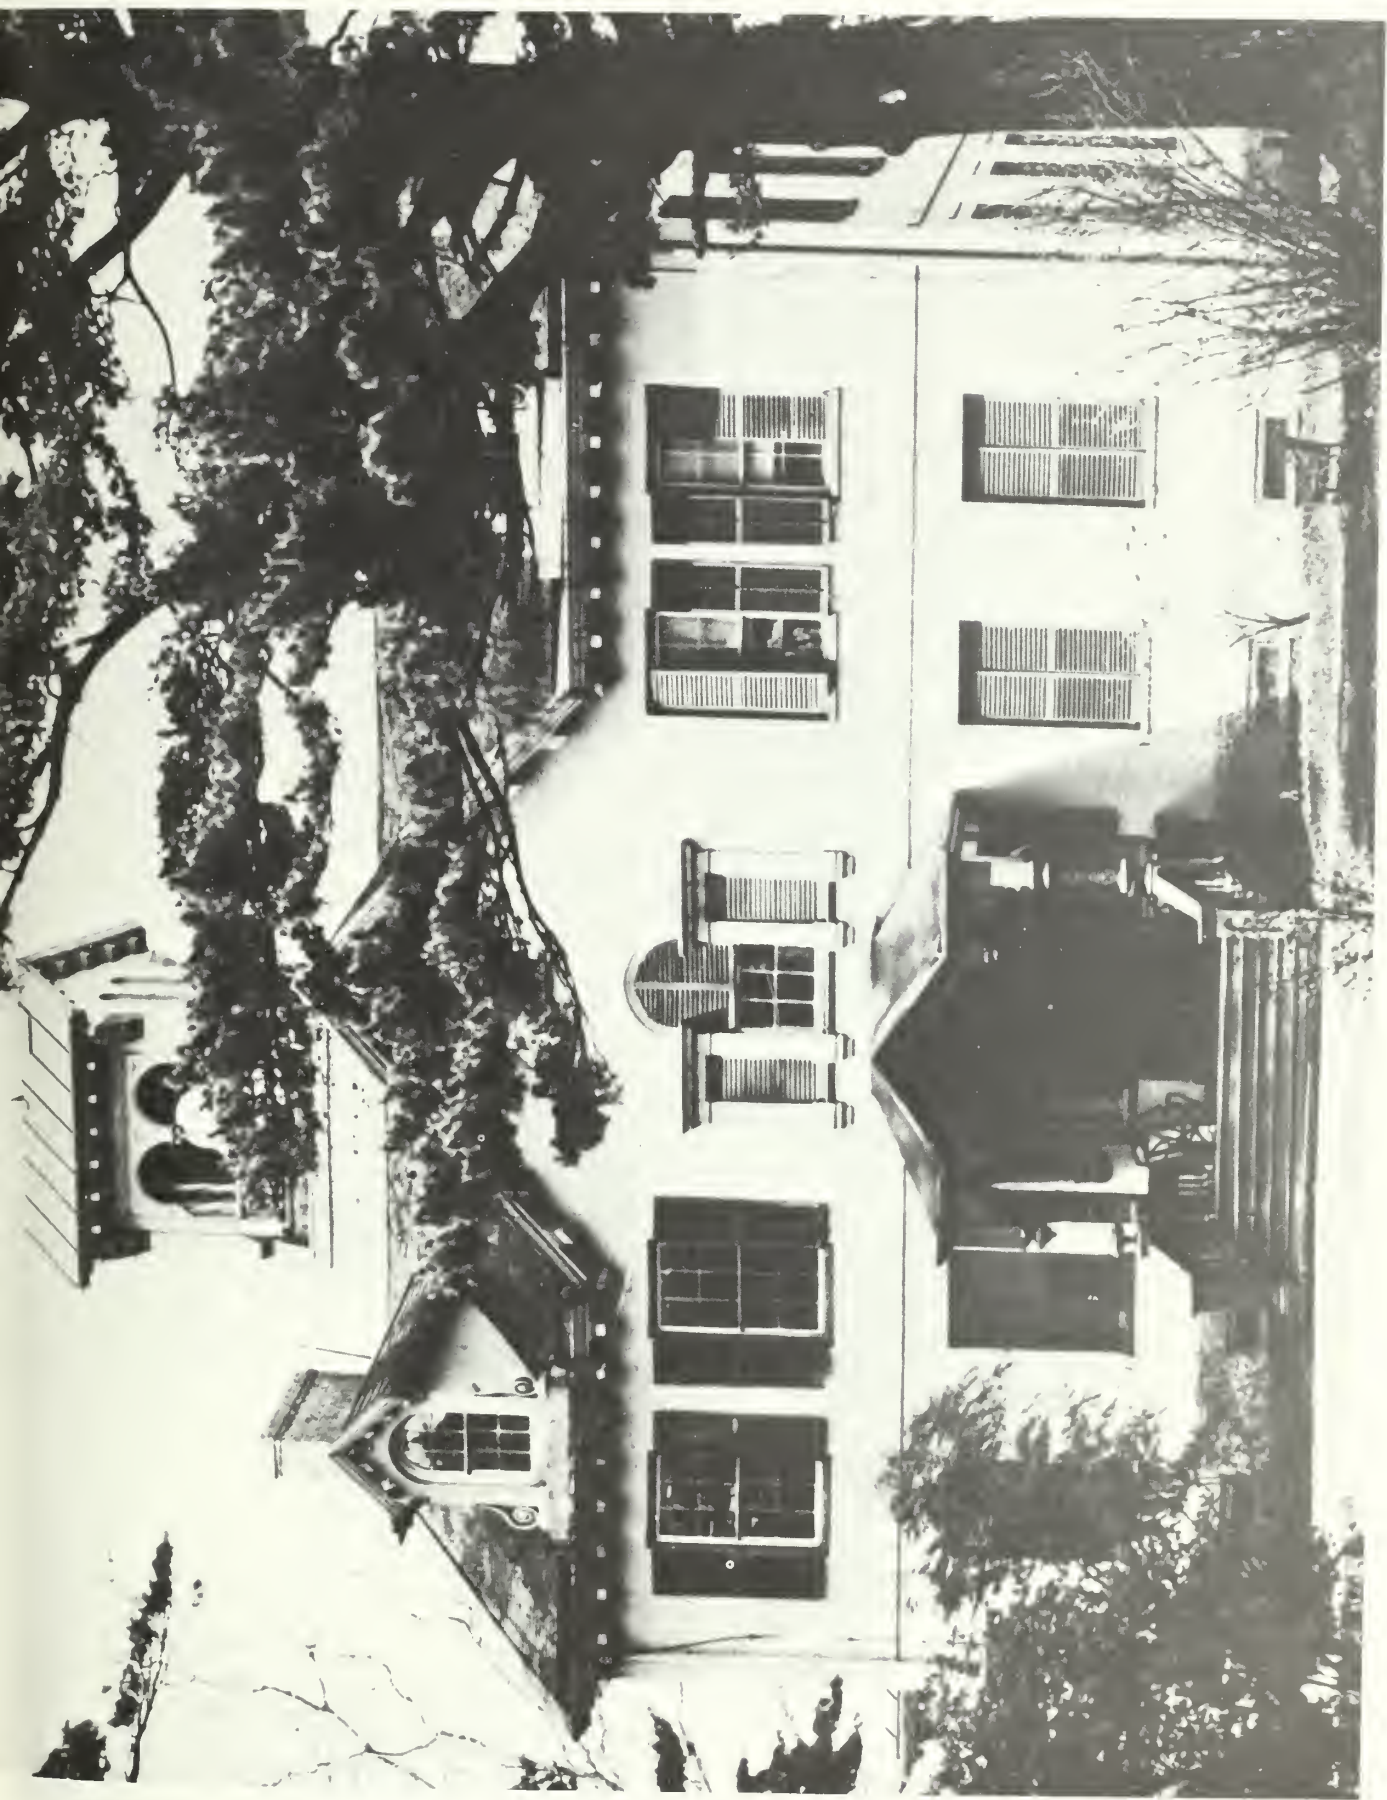
HP11. Lindenwald, East Elevation, ca. 1913-1917. This date is based on similarities with HP10, the fact that the hydrangeas are slightly larger, the state of deterioration of the dormer sill boxes, the continued presence of lightning rods, and the wood shingle roof. The following details should be noted:

The foundation window frames, shutters, and front porch appear to be painted a darker tone. Sash, bricks, and cornice appear to be painted a lighter tone.

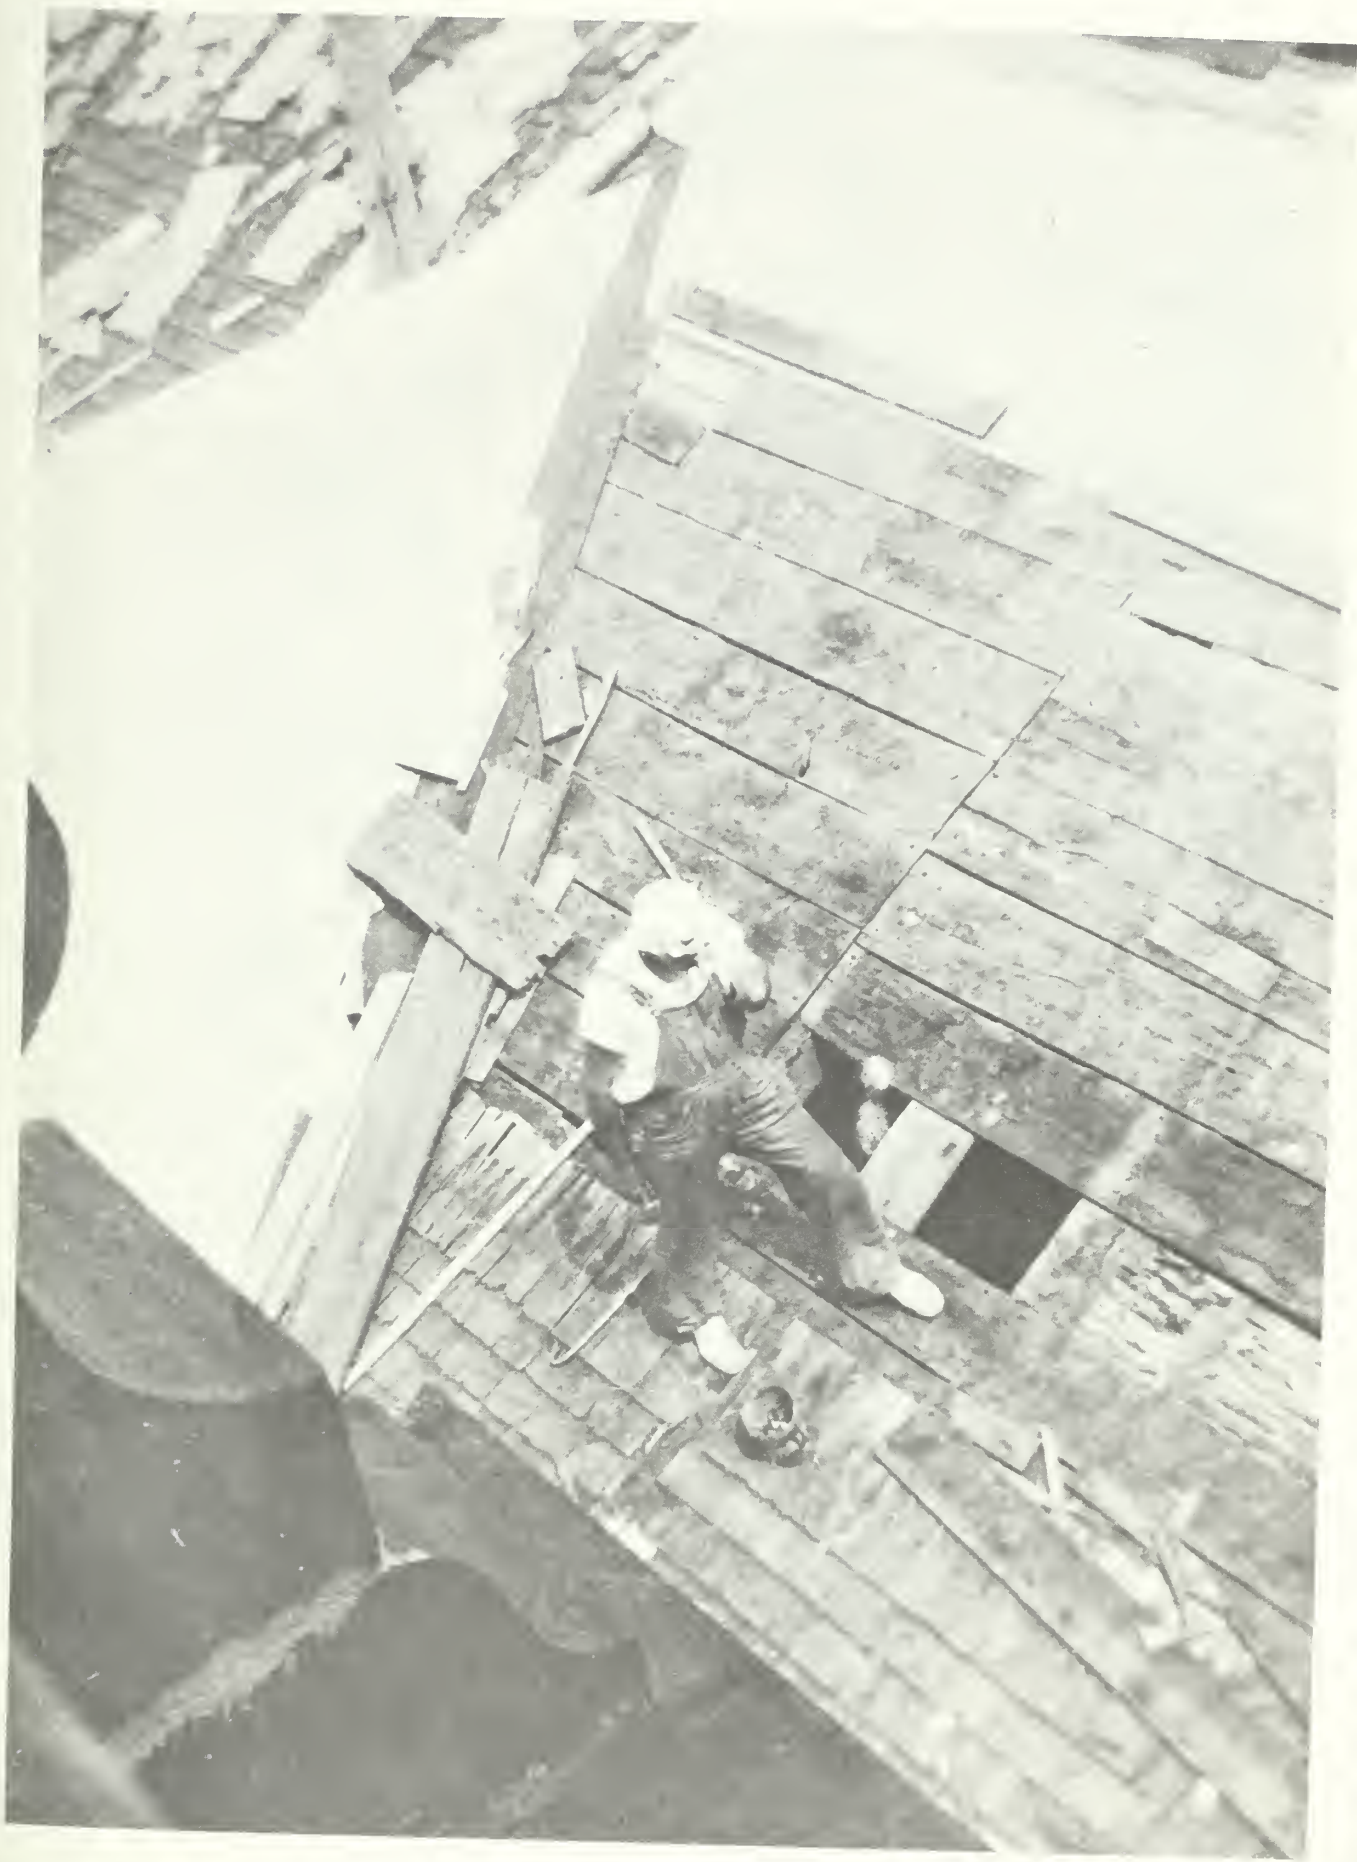
HP15. This photograph again shows Dr. Bascom Birney in the process of removing shingles from the west slope of the ca. 1797 roof. Note the roofing bracket near the top right corner of the photograph.

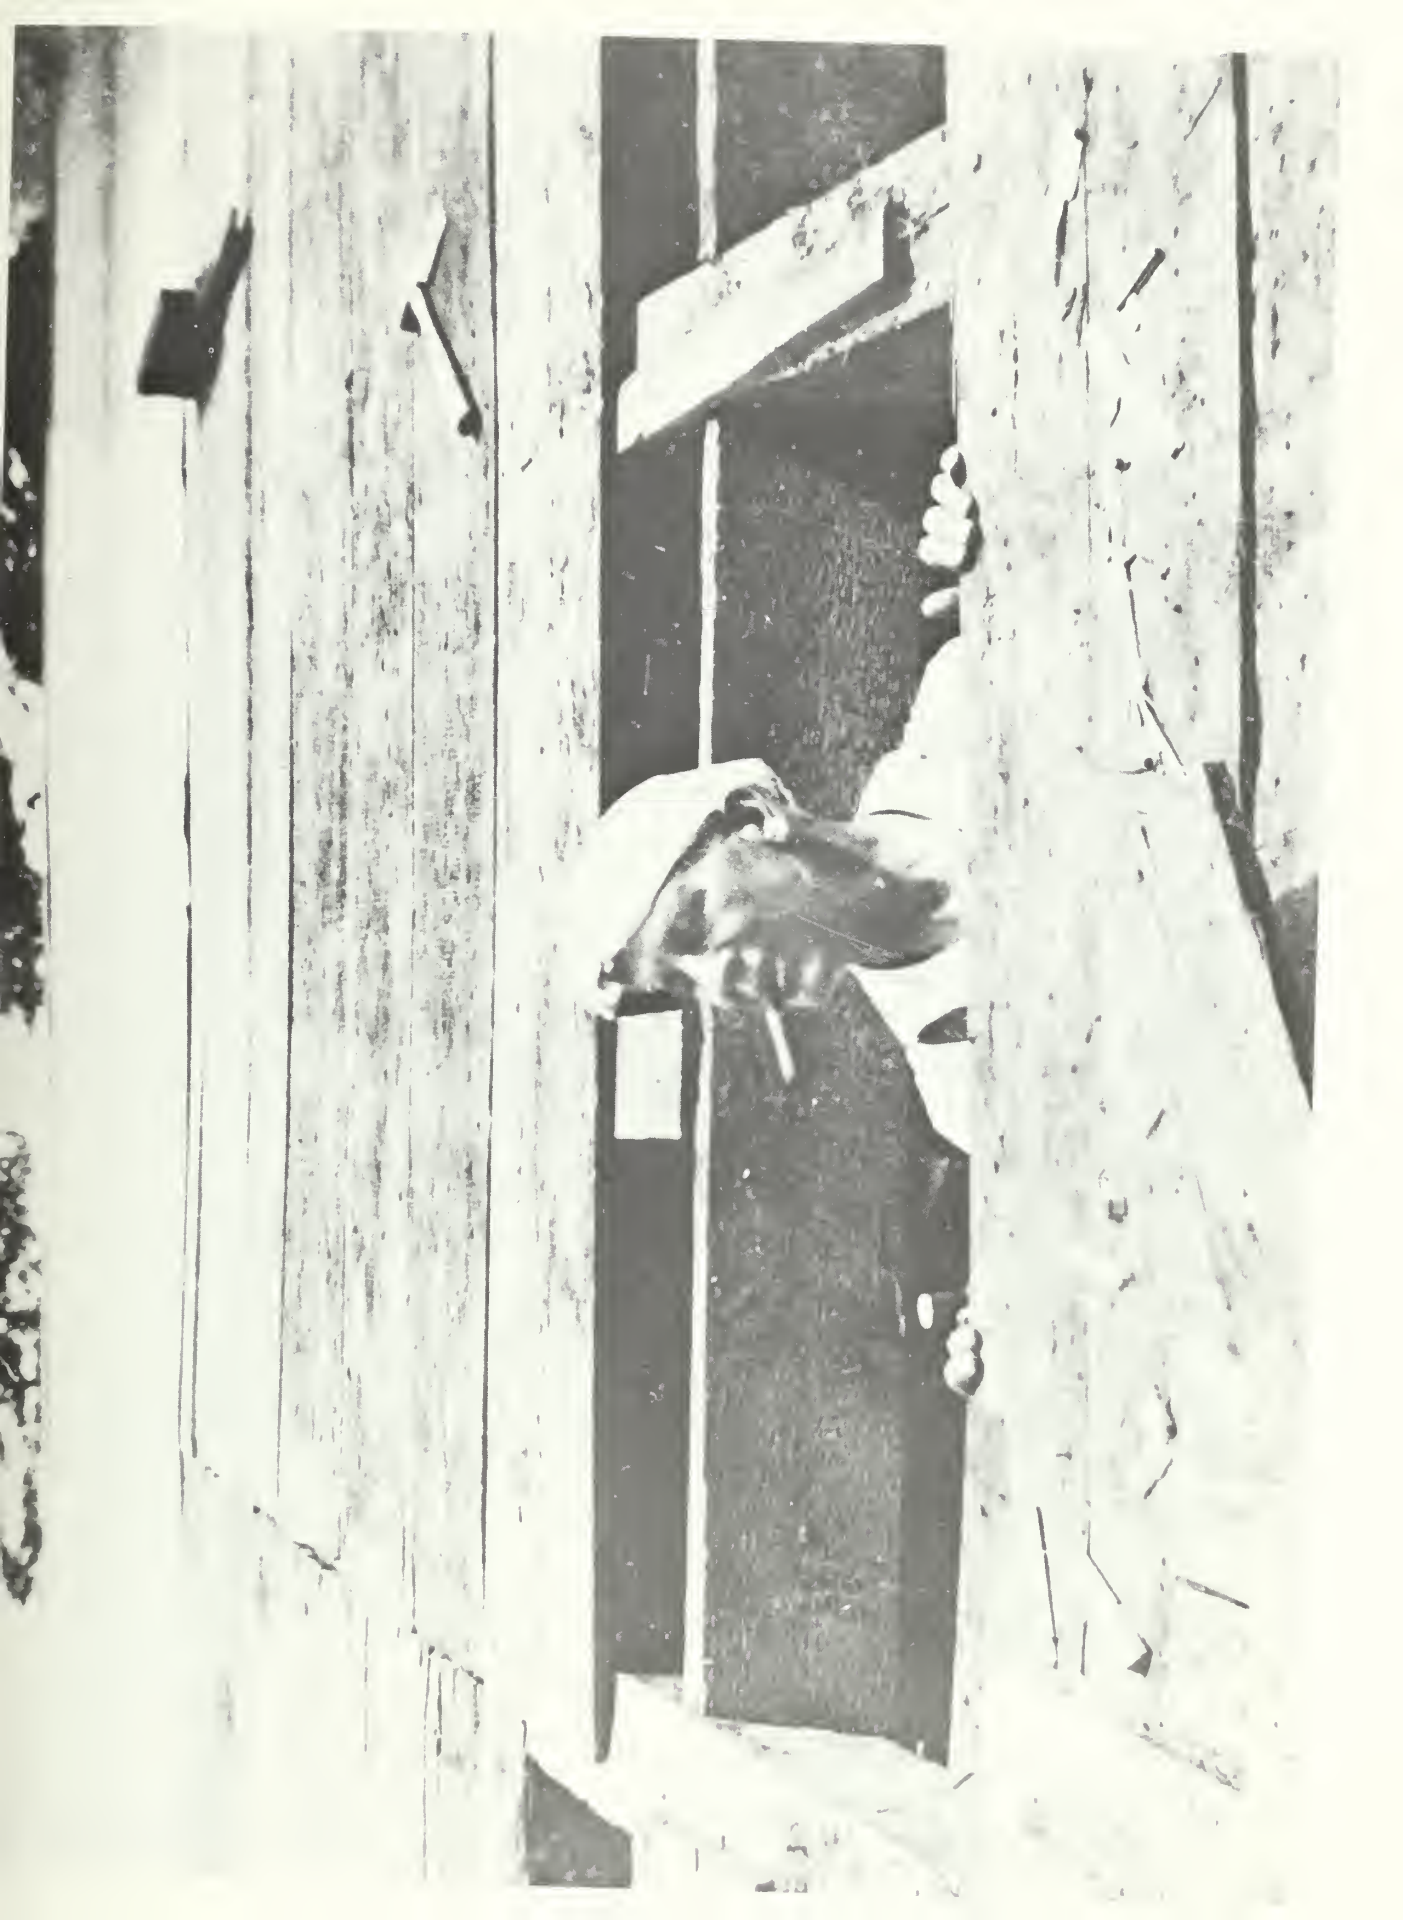
HP16. South Wall of Room 105, ca. 1924. This photograph was published in 1924 in Historic Wallpapers from their Inception to the Introduction of Machinery, by Nancy V. McClelland. Note particularly the glass shades on the kerosene chandelier and the absence of the bell pull wire that appears in HP13.

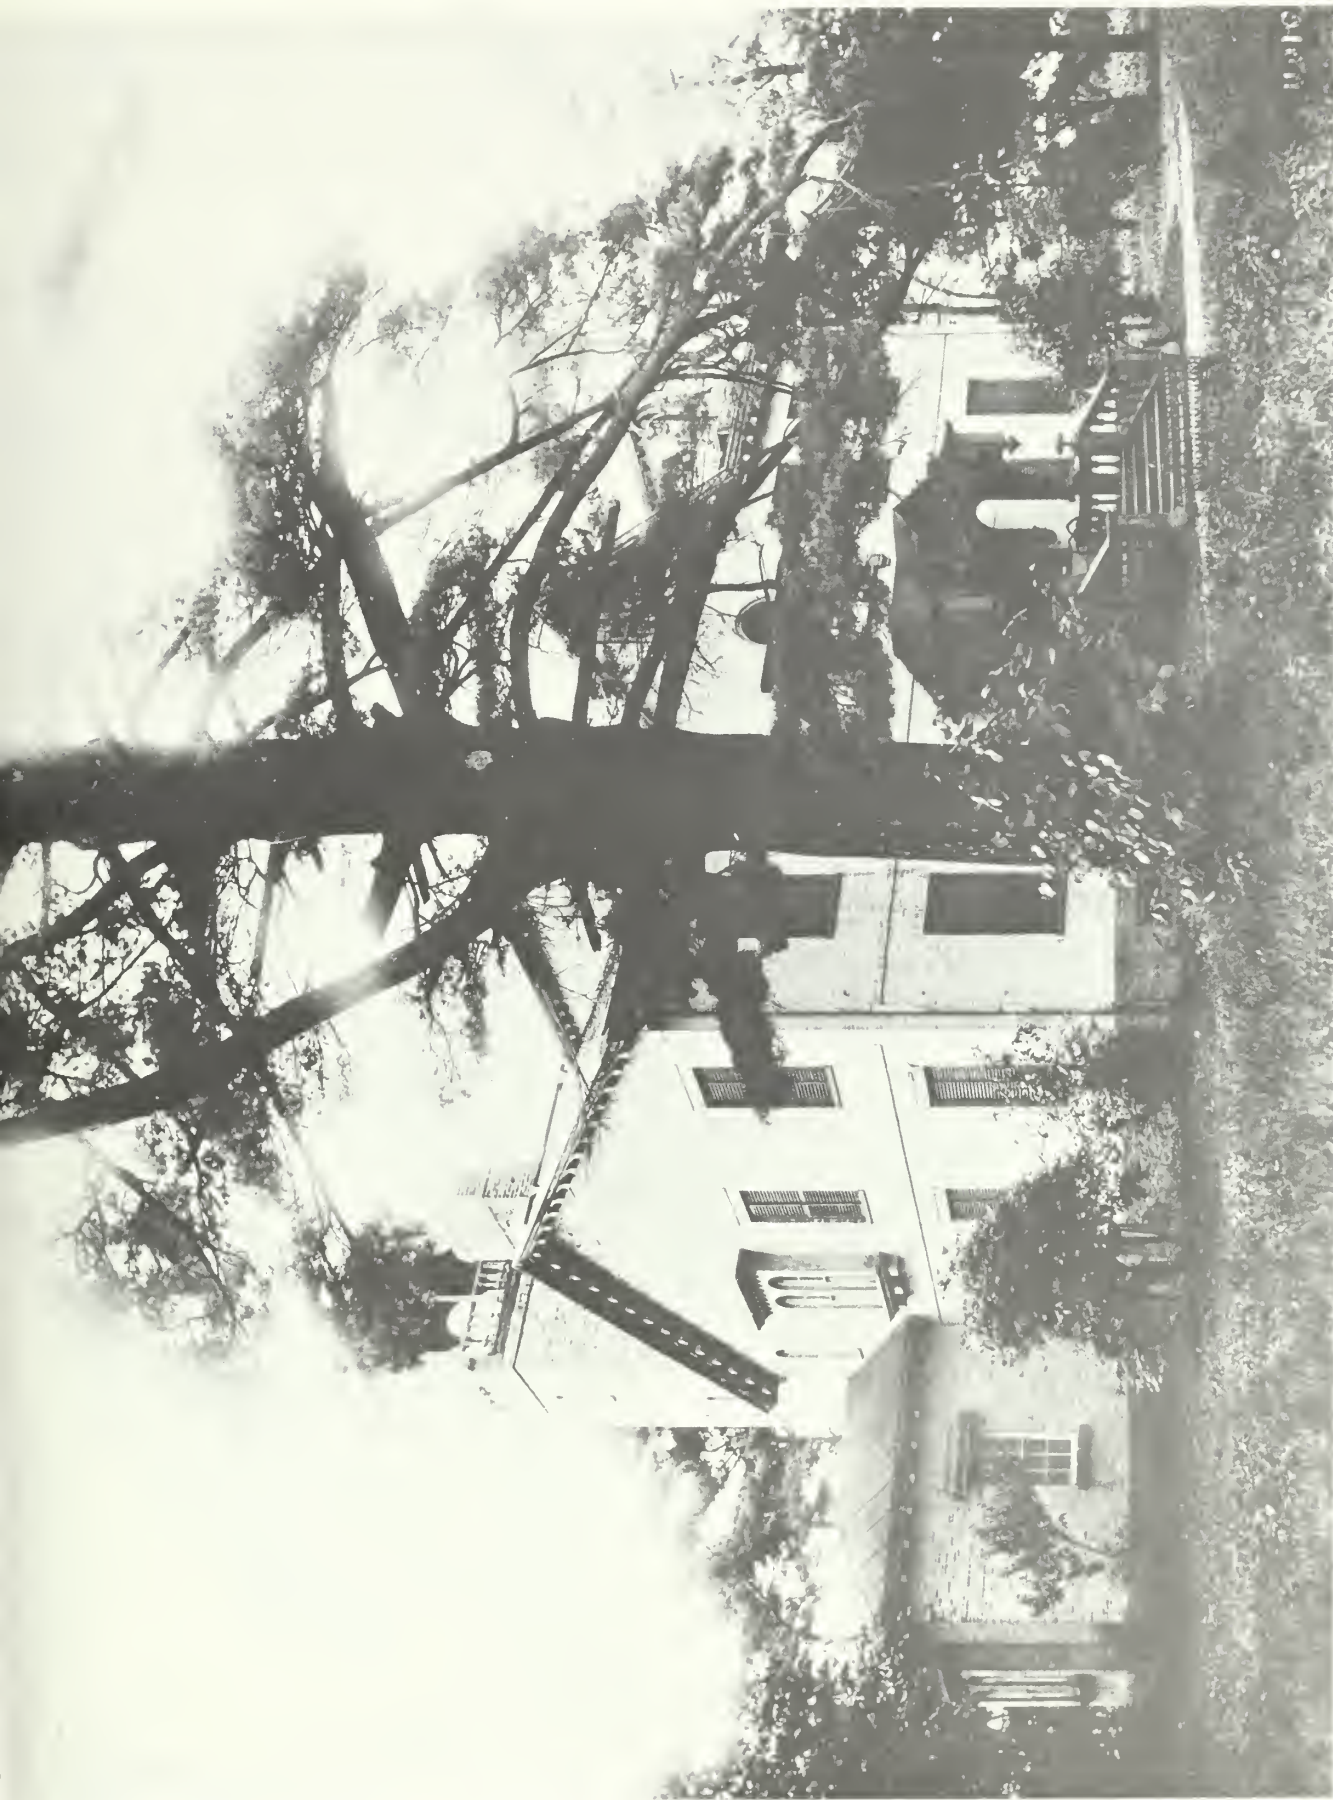
HP19. This photograph is a detail of HP18.

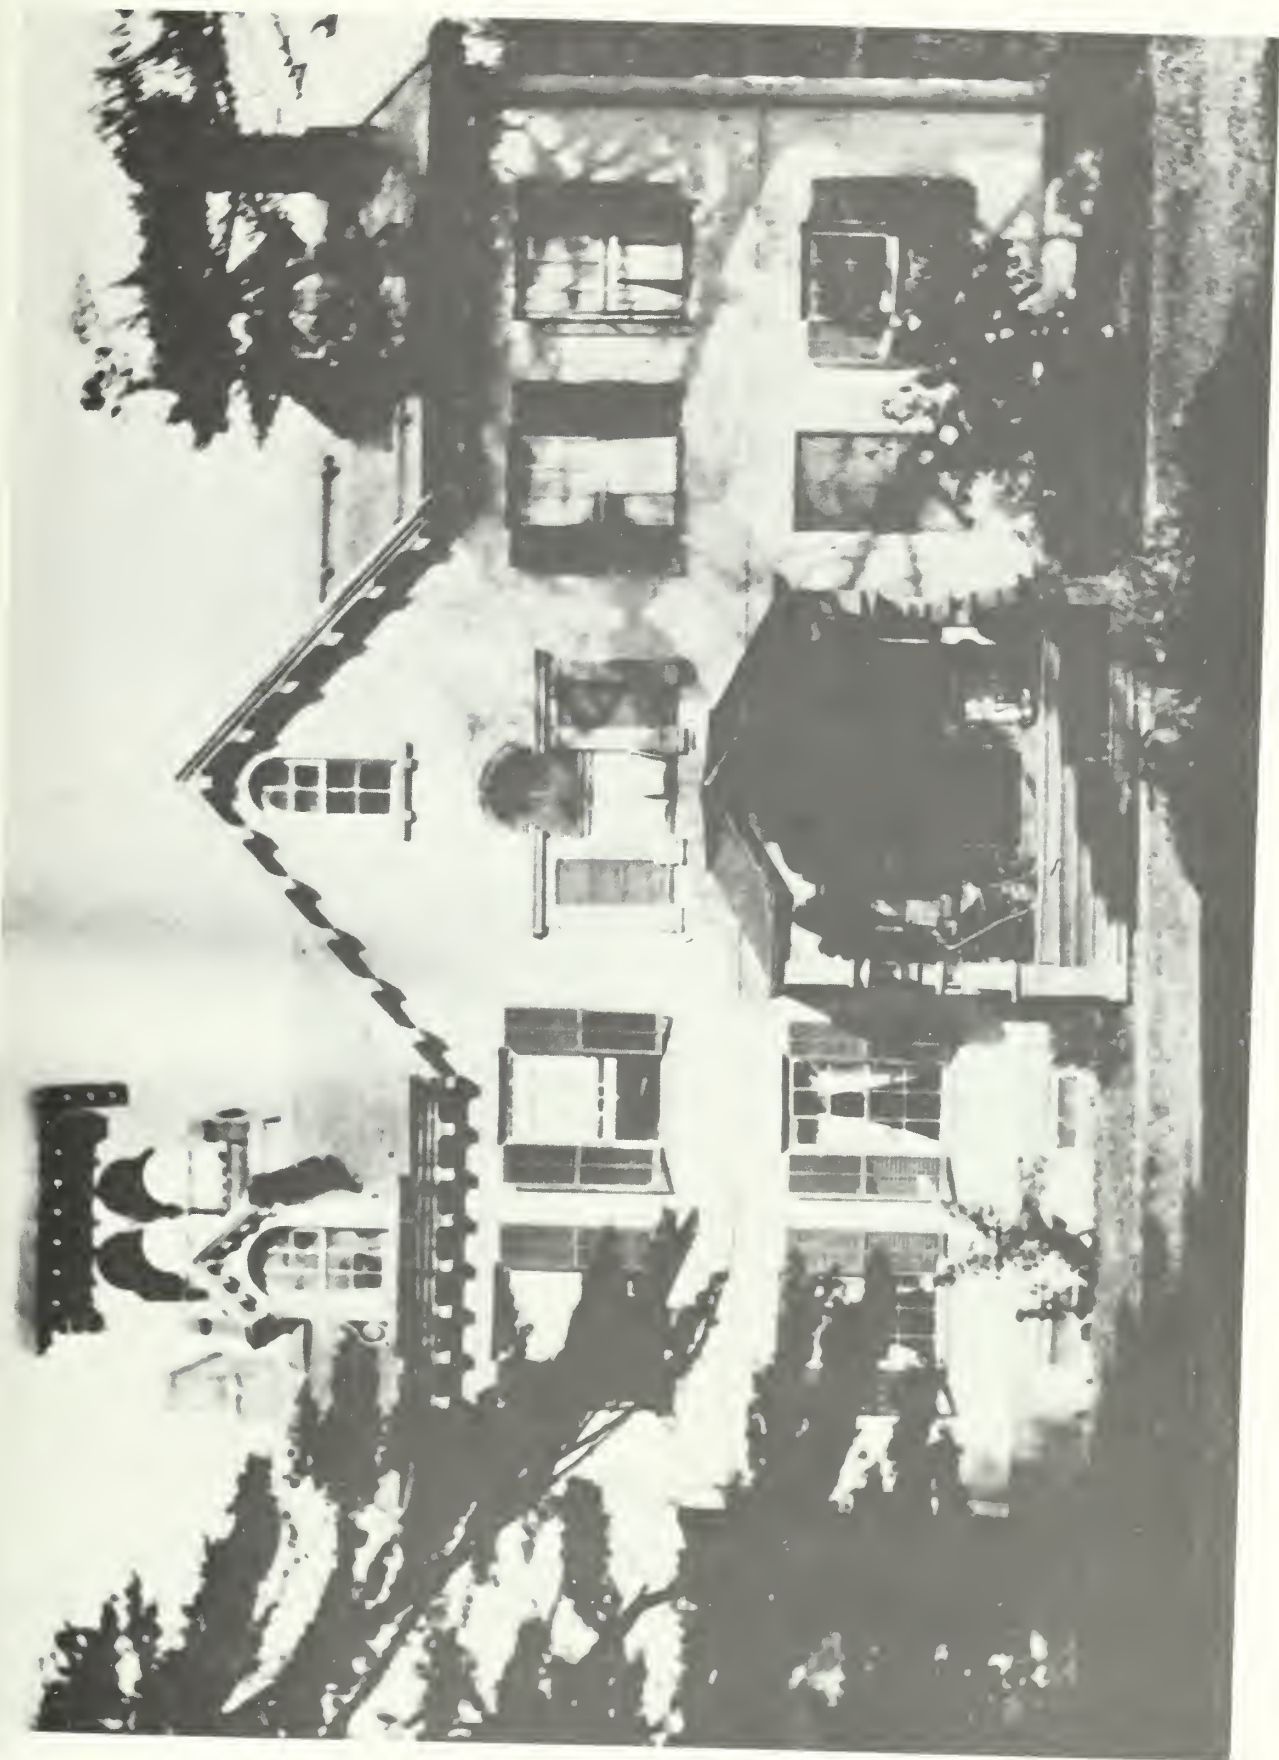
HP21. Clementine Birney and William DeProsse in Room 104, 1925. This photograph was taken at the time of their wedding in 1925. The background is the south wall of the room and door 102. Note the white-painted woodwork, the historic Brussels carpeting, the historic wallpaper, and the bed.

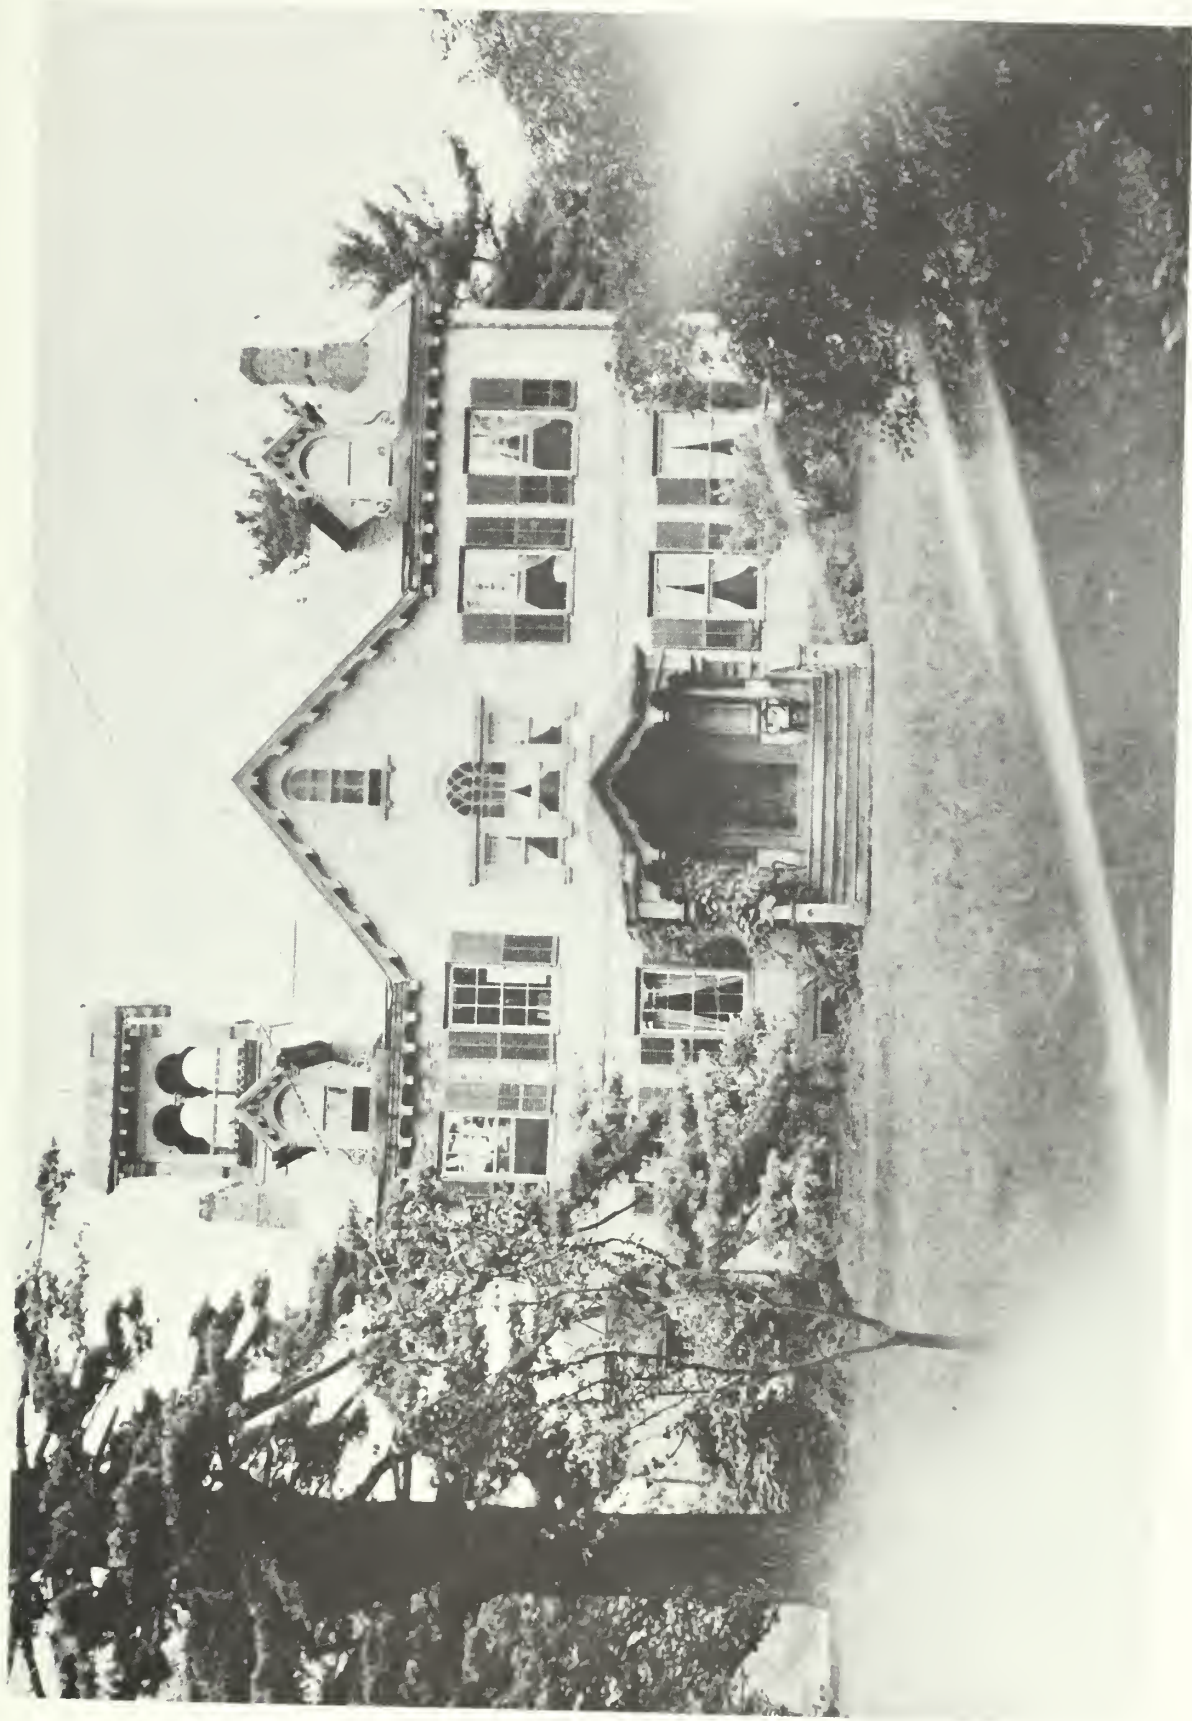
HP25. Ca. 1850 Front Porch, 1936. This photograph was taken by Melvin Weig on August 3, 1936. The following details should be noted:

pattern of seams in sheet-metal roofing

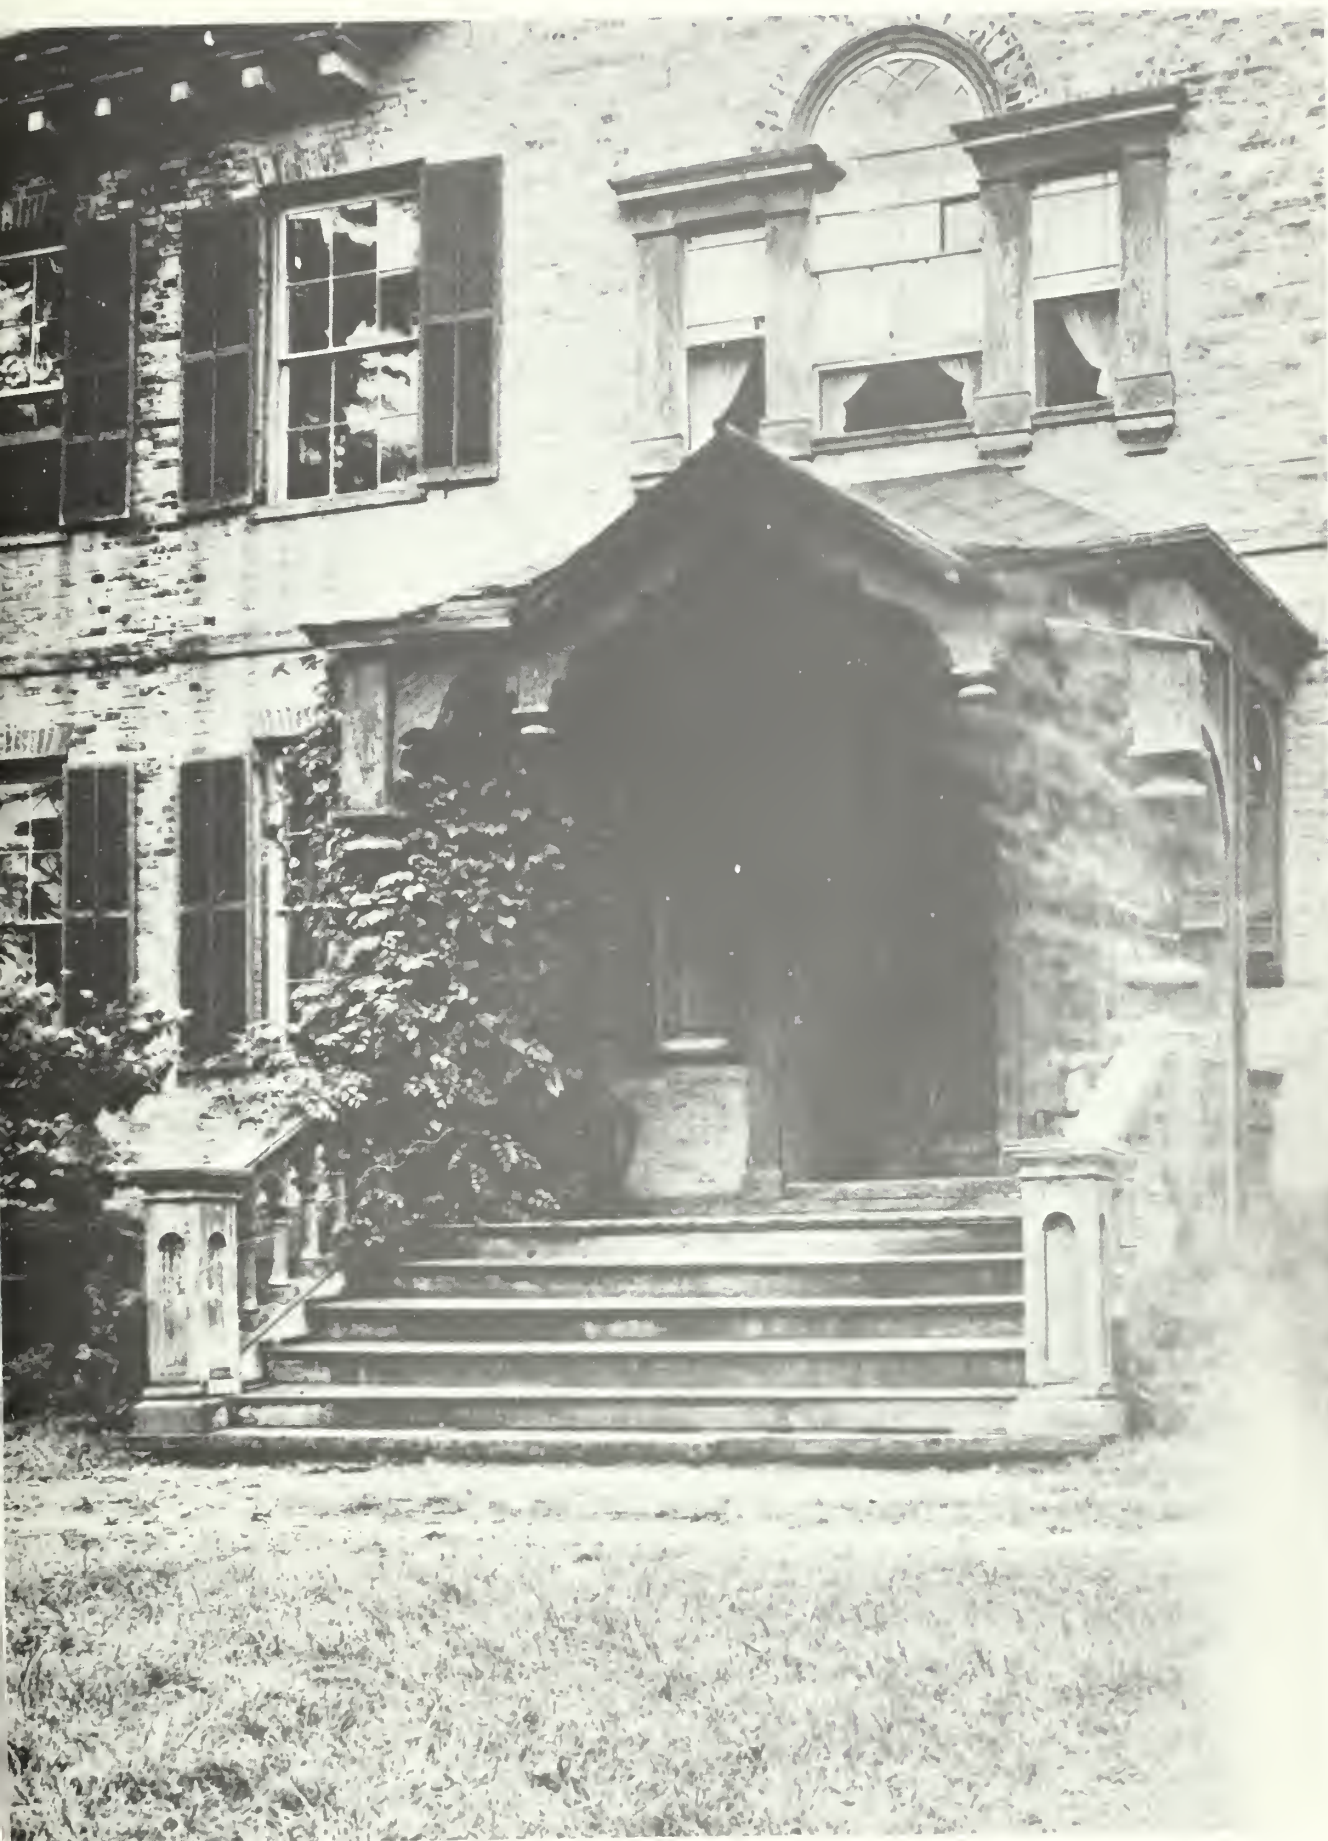
HP26. North Side of Lindenwald, 1936. This photograph was taken by Melvin Weig on August 3, 1936. The following details should be noted:

There is new flashing on the north gable capping board and a rainwater diverter at east end.
